LPC# 1210500002 Marion County
Sandoval Zinc Co. - Sandoval
ILD 053 980 454
F/HRS

Expanded Site Inspection

Sandoval Zinc Company
Box 263 Smelter Road Highway 51, Sandoval, Illinois
ILD 053 980 454

April 5, 2010

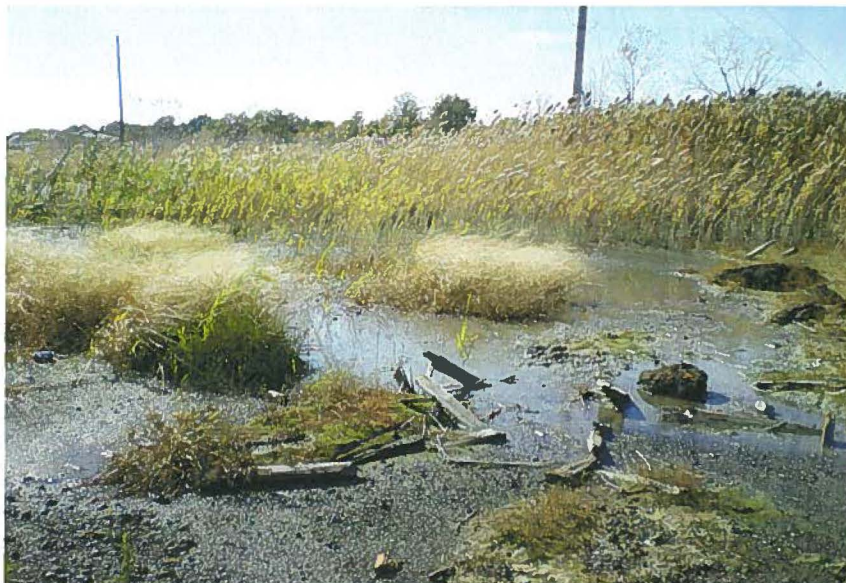
Picture taken of the drainage of water from the site to the southwest corner of the site.

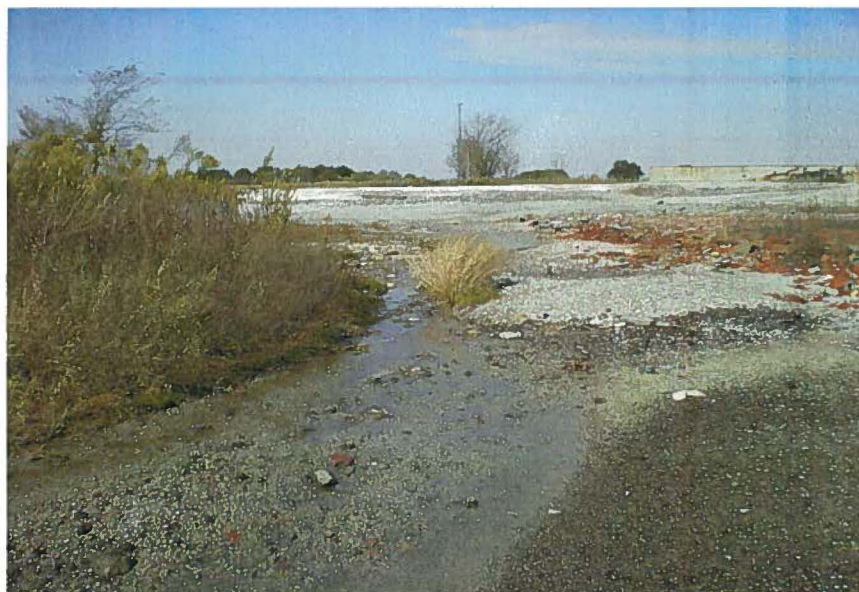
Picture taken of the surface water draining south off of the site.

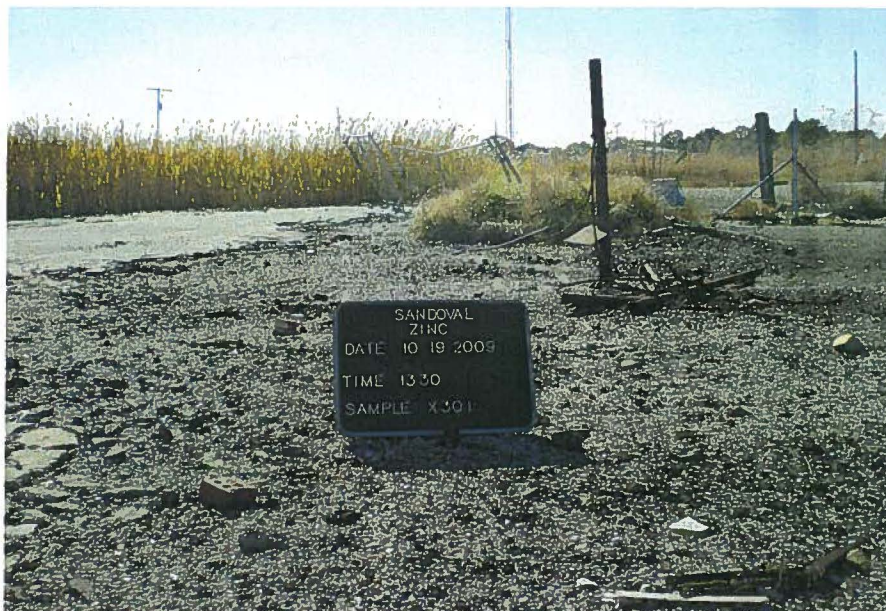
Picture is taken to the southwest of sample X301. This is near the southwest corner of the Sandoval Zinc property. Sample was taken from a depth of 0-2 inches from a light gray material with rocks and gray sand.

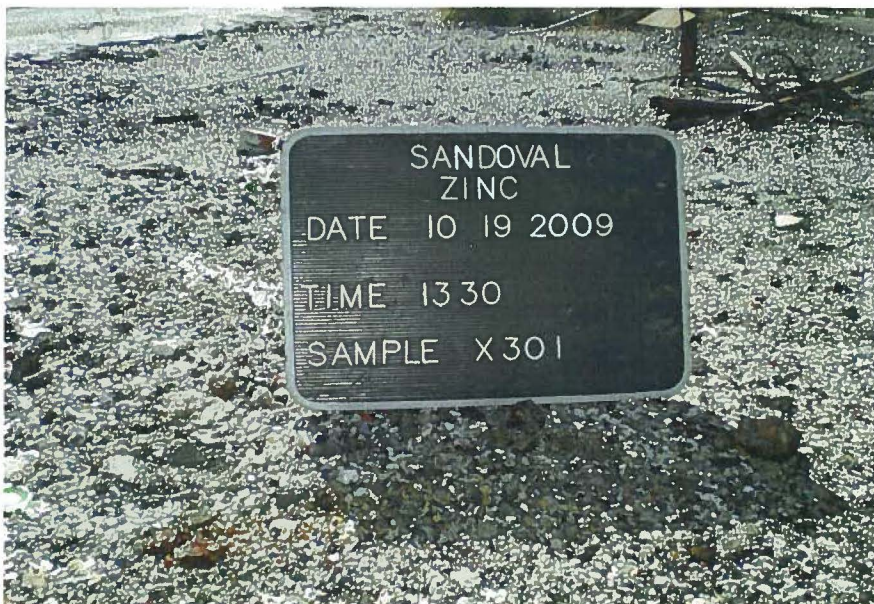
Picture is taken to the southwest of sample X301. This is near the southwest corner of the Sandoval Zinc property. Sample was taken from a depth of 0-2 inches from a light gray material with rocks and gray sand.

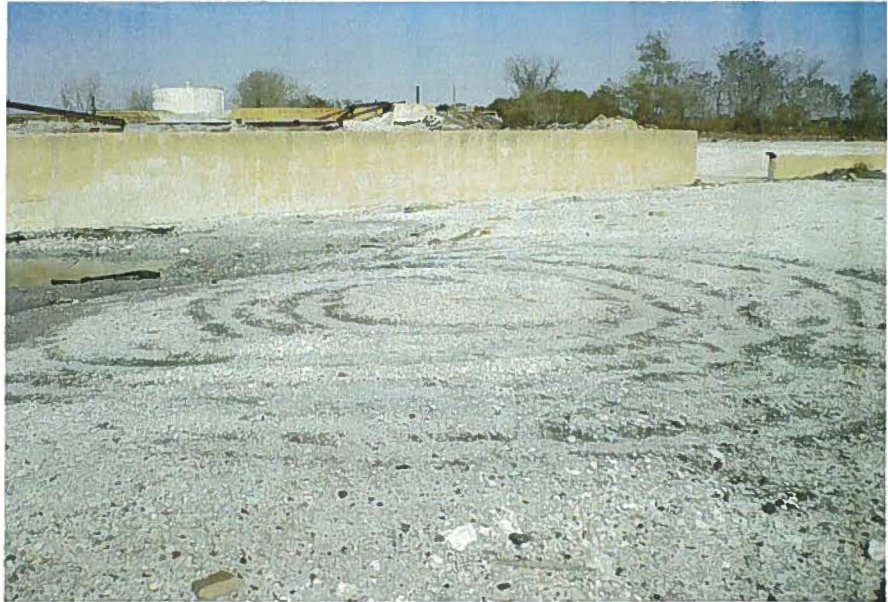
Although the site is fenced, areas of the fence have been trampled or driven over, thus the fence is not a deterrent to trespassing. Evidence of trespassing has been documented with various pictures of vehicle tracks. Soil exposure to these individuals is a possibility. Also of a concern is the practice of all terrain vehicles stirring up the cinder/slag material and dust. This would enhance the possibility of individuals inhaling hazardous material.

Picture was taken to identify human trespassing at the site. Photo depicts four-wheeler tracks at the site in a radial pattern indicating that donuts were being conducted at the site and in all probability stirring up contaminated dust.

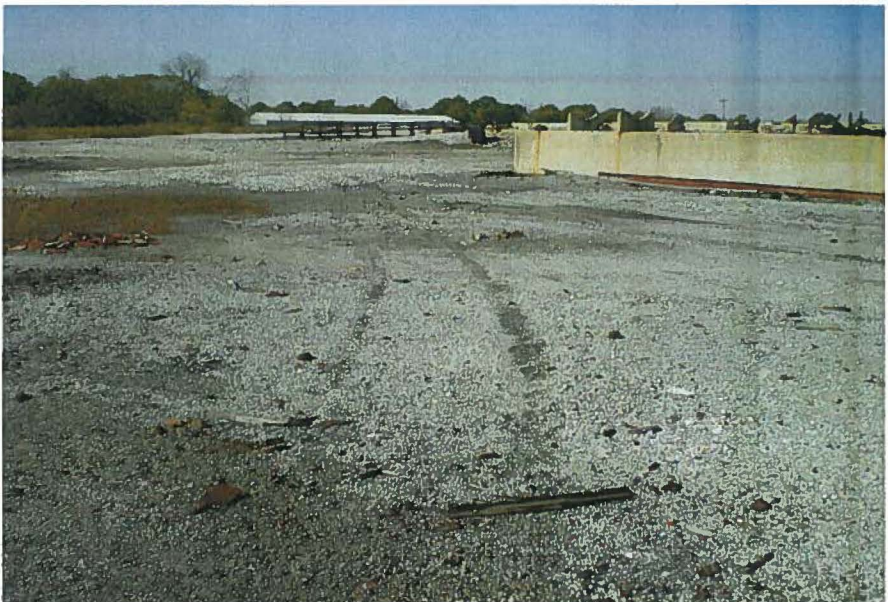
Picture taken of vehicle tracks through the property. Evidence of trespassing activity.

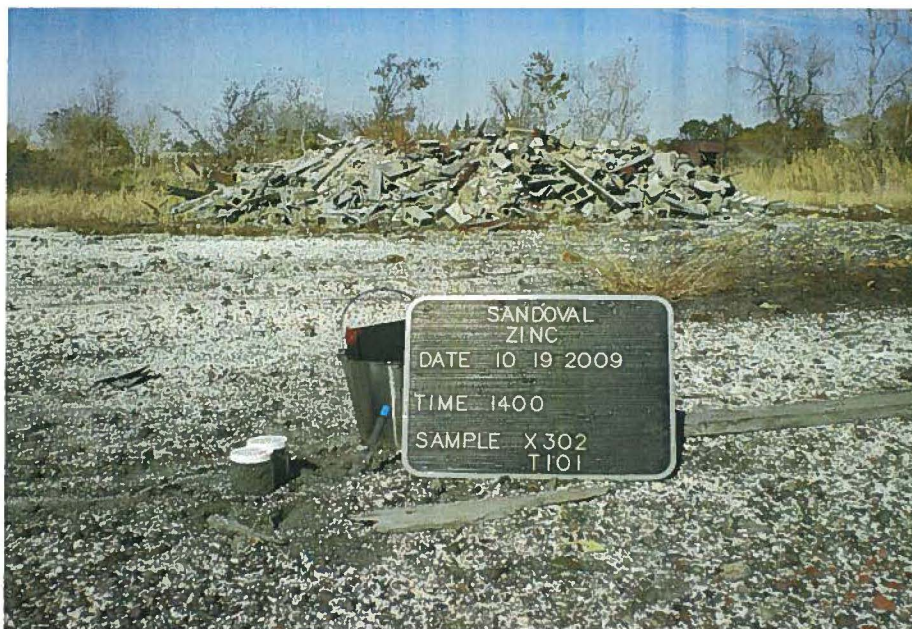
Photo taken of Samples X302 and T101. These samples were collected from 0-2 inches and consisted of a dark gray sandy silt material.

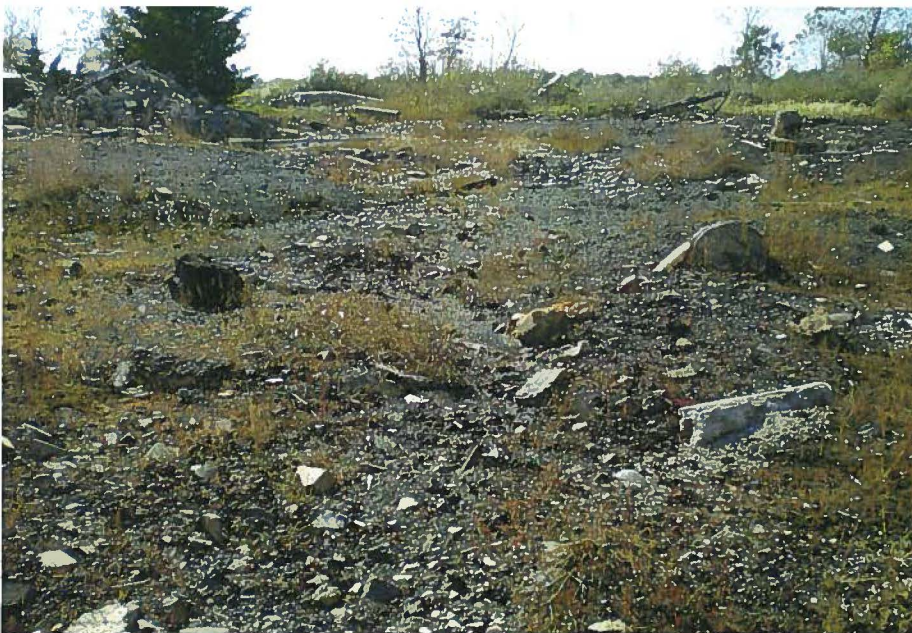
Photo taken of the drainage pathway from the site draining to the east towards the fence and wetlands.

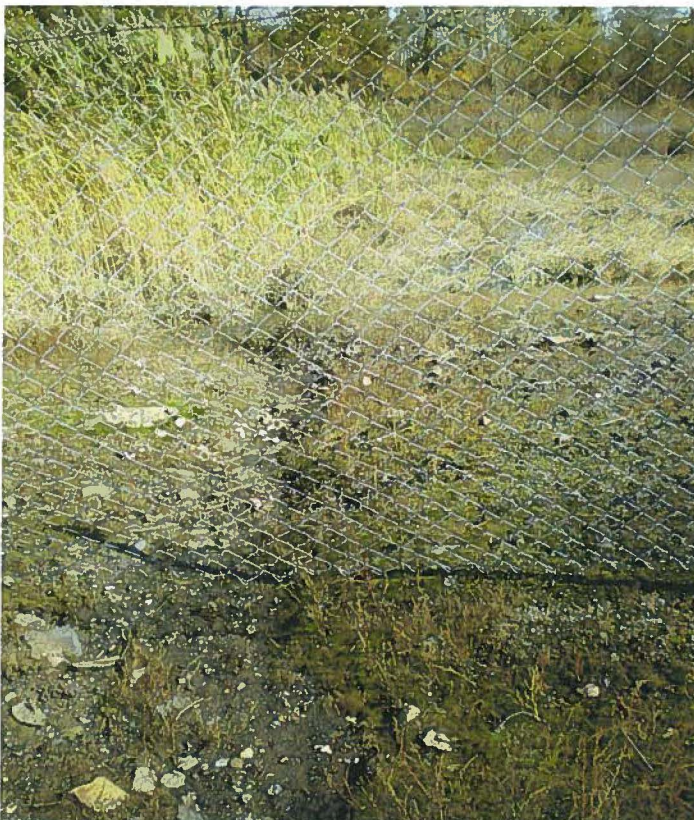
This photo was taken to continue the drainage pathway from the site towards the wetlands and pond located east of the fenced portion of the site.

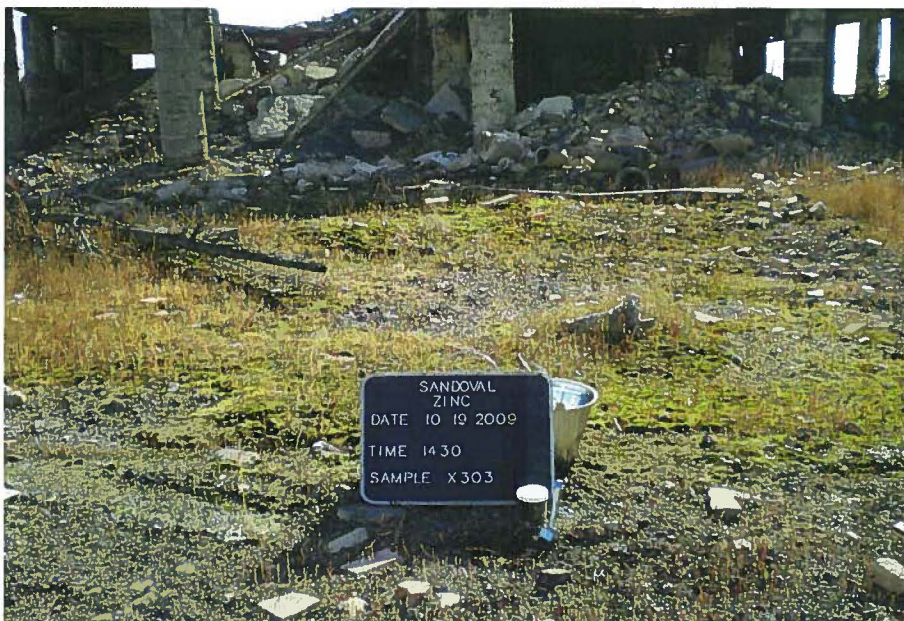
This photo was taken of sample X303 near the northeast corner of the fenced portion of the property. Sample was collected from a depth of 0-2 inches from a black cinder material. Notice the remnants of the furnace in the background.

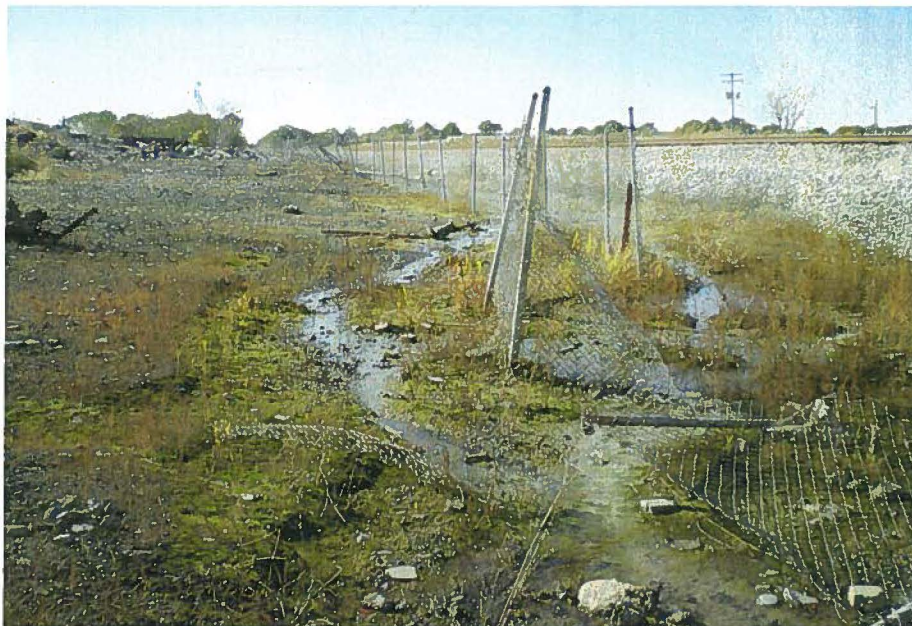
This photo was taken of the surface water drainage from the north side of the site which flows east along the railroad tracks to the wetlands located at the east end of the fenced property.

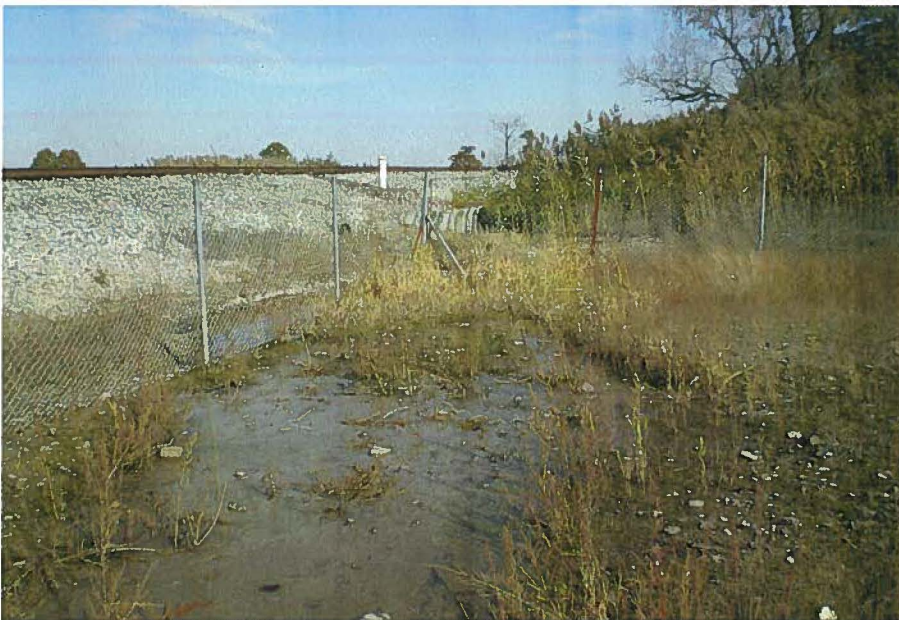
This photo is a continuation of the surface water drainage from the north side of the site. This photo depicts the water from the site flowing to the wetlands located east of the fenced portion of the property.

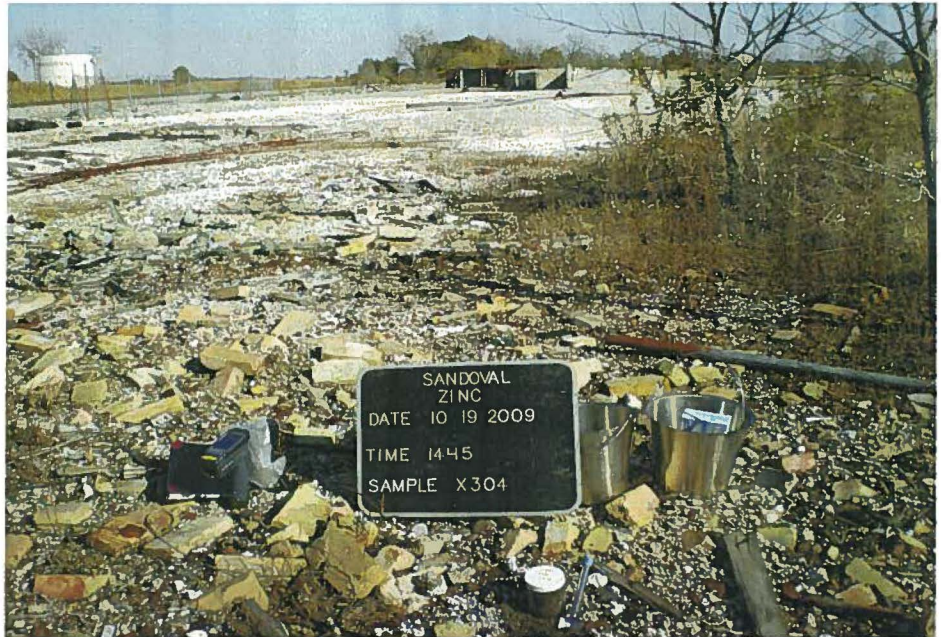
This photo was taken of sample X304. This sample was collected from the northwest corner of the fenced property from a depth of 0-2 inches from a reddish brown sandy material.

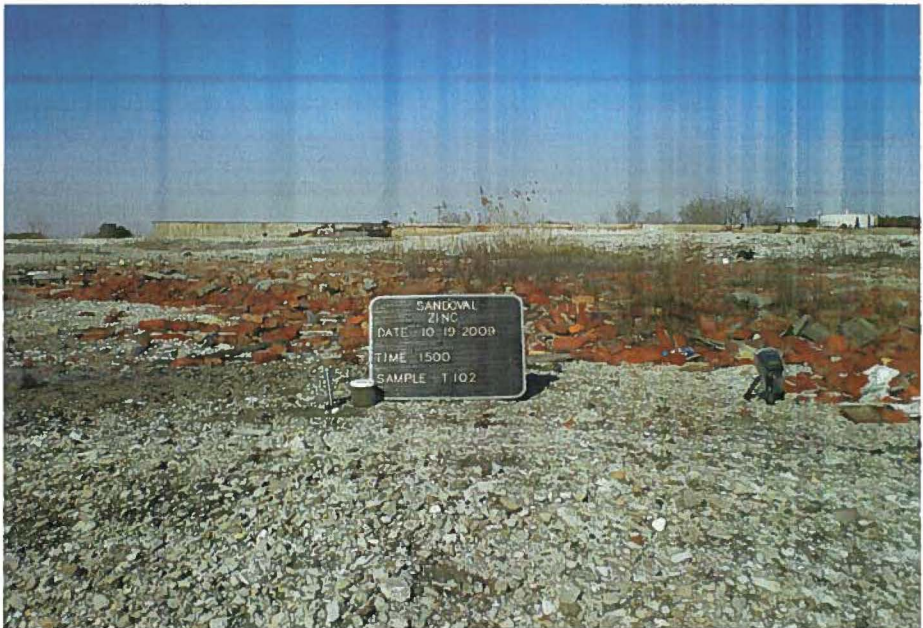
Photo was taken to the north of T102. T102 was collected from a black cindery material from 0-2 inches.

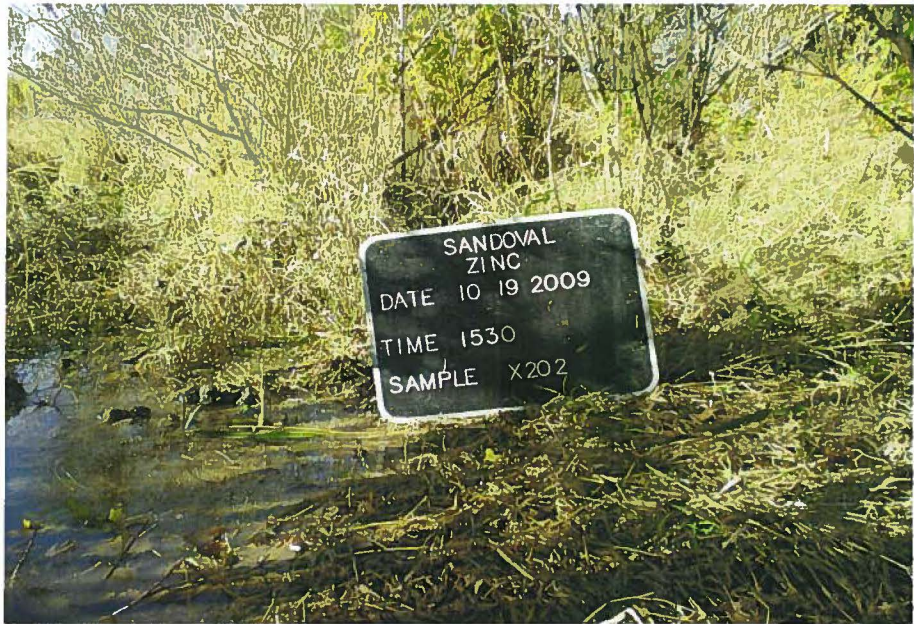
This photo was taken of sample location X202. X202 was collected from a low lying area in which drainage from wetlands was present. X202 was collected from a depth of 8 inches from a brown silty sediment.

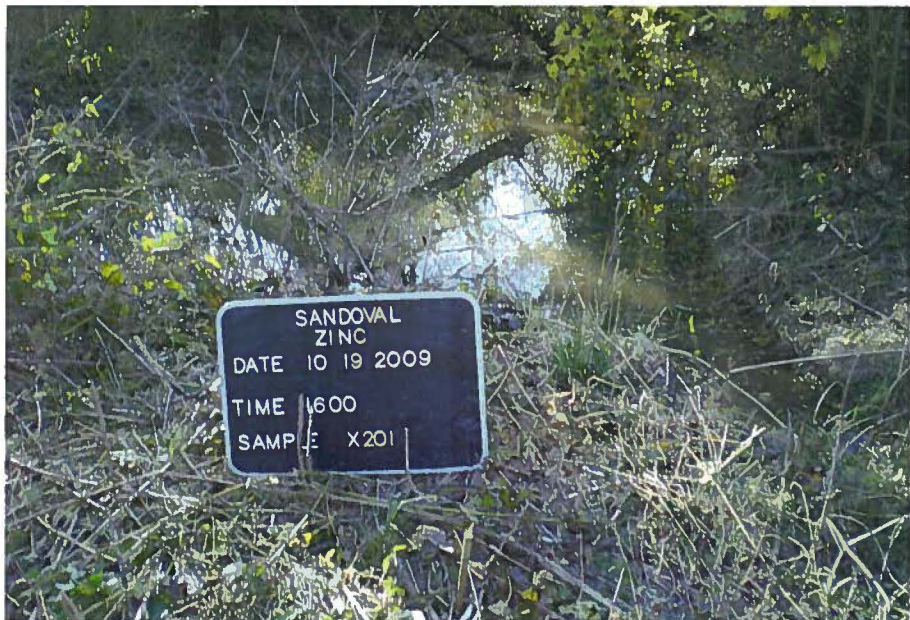
Photo taken at 1600 of sample X201. X201 was collected at the confluence of one of the surface water pathways as it enters into Prairie Creek. X201 was collected from a brown silt from a depth of 0-3 inches.

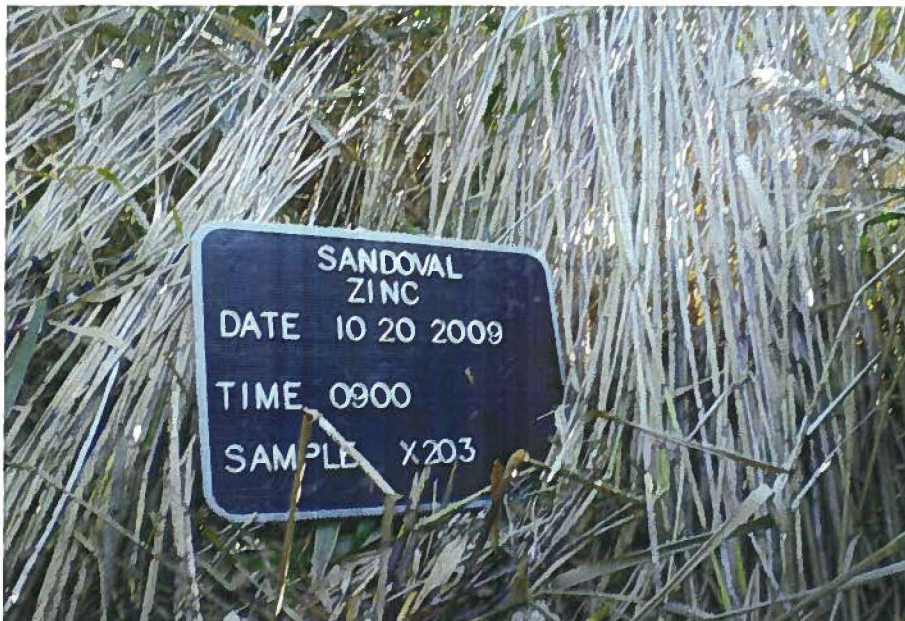
Photo taken of sample location X203. Phragmites present everywhere. Sample was collected from the deepest area of the drainage area in the wetland. X203 consisted of a slightly gritty slightly sandy clay. Sample was collected from a depth of 8 inches.

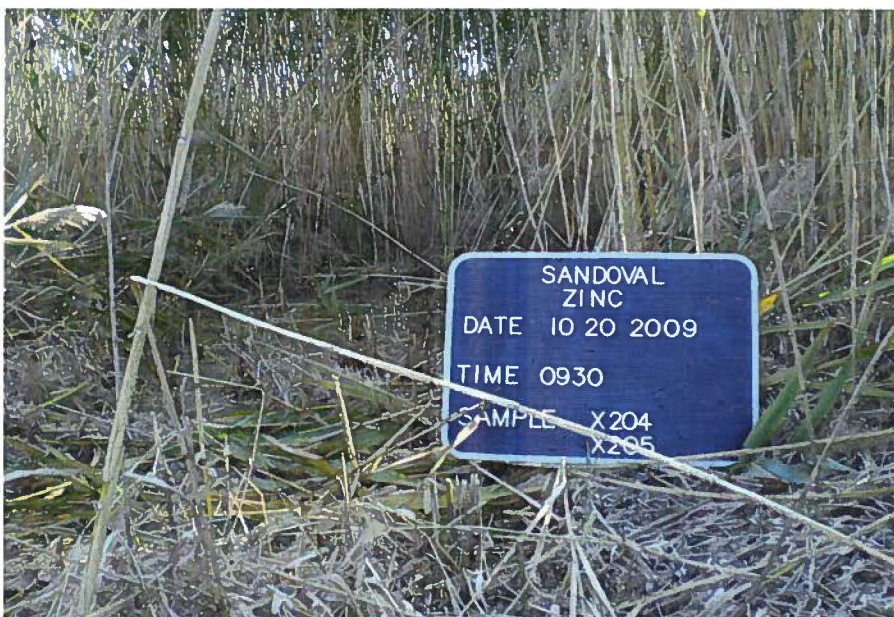
Photo taken of Sample X204 and X205 duplicate. Sample location was within the wetlands. Sample was collected from lowest portion of the wetlands in this area. Sample was collected from a depth of 12 to 16 inches from a light brown sandy silt with some clay.

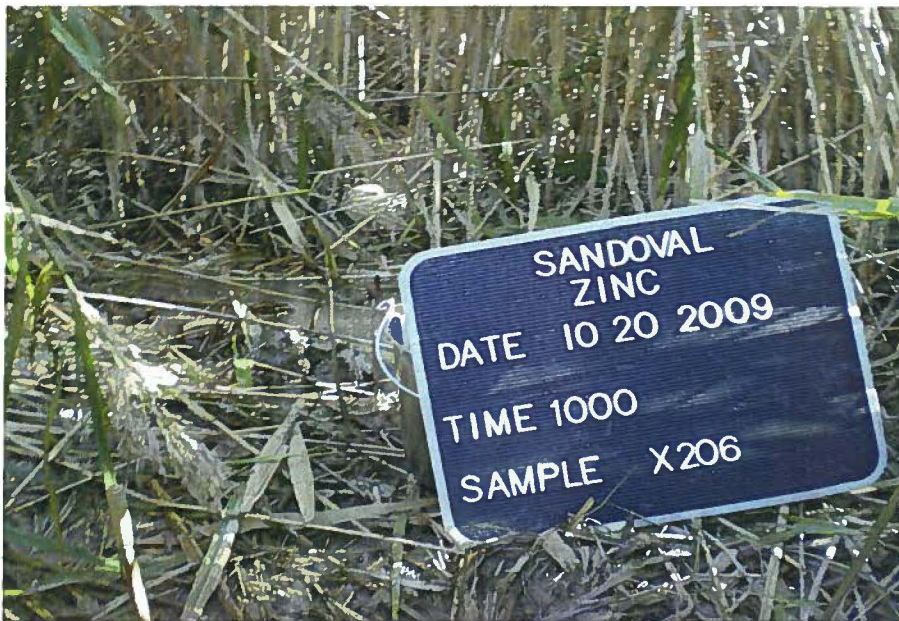
Photo was taken of sample location X206. X206 was collected from the wetland area. X206 consisted of a brown silt with some grit from a depth of 8-10 inches. This location is near the four wheeler crossing southeast of the site.

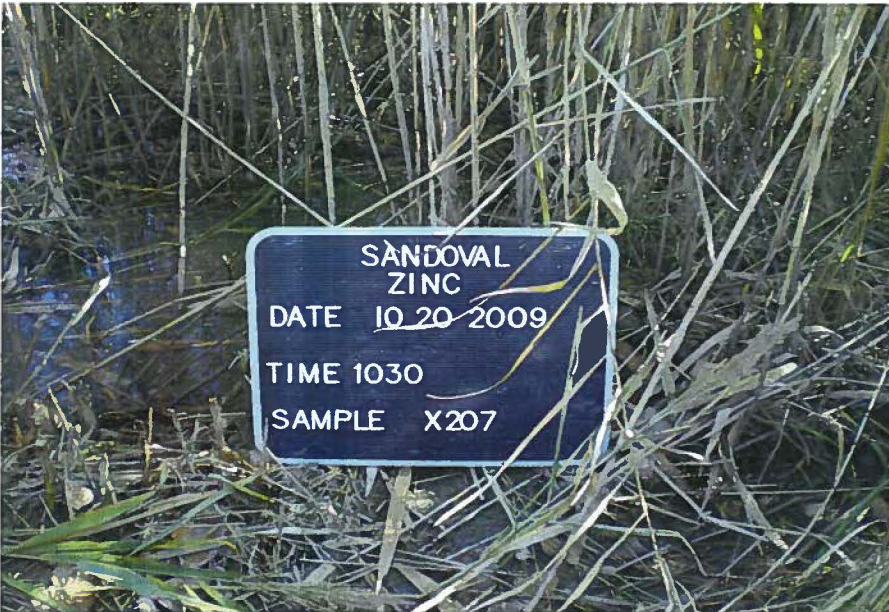
Photo was taken of sample location X207. X207 was collected from a lowlying area within the wetlands. This location was at the east side of the four wheeler path. X207 was collected from a brown silt with some clay and grit from a depth of 6 inches.

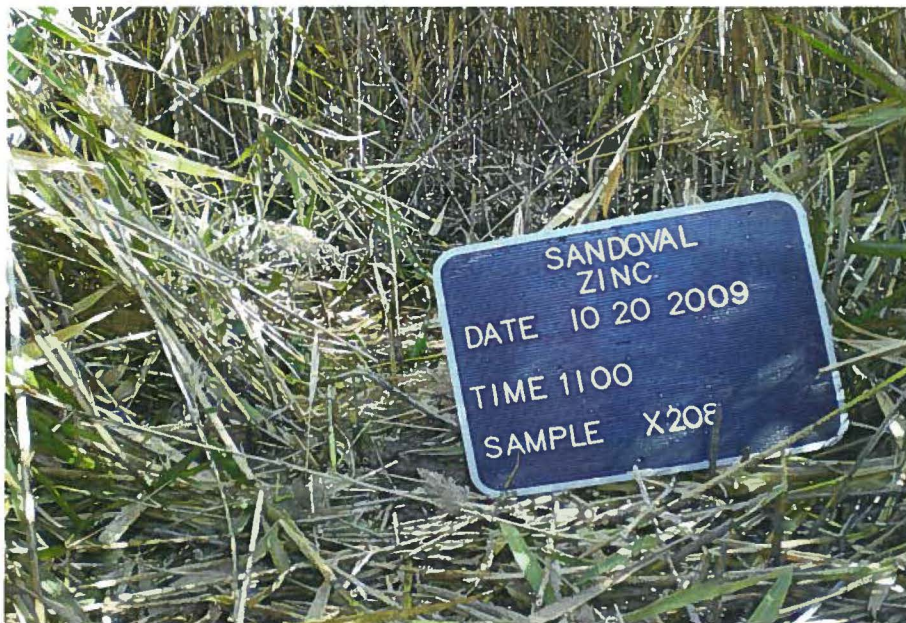
COMMENTS:
 Photo taken of sample location X208 from the wetland area. X208 consisted of a silty sand with many roots from the phragmites from a depth of 8 inches.

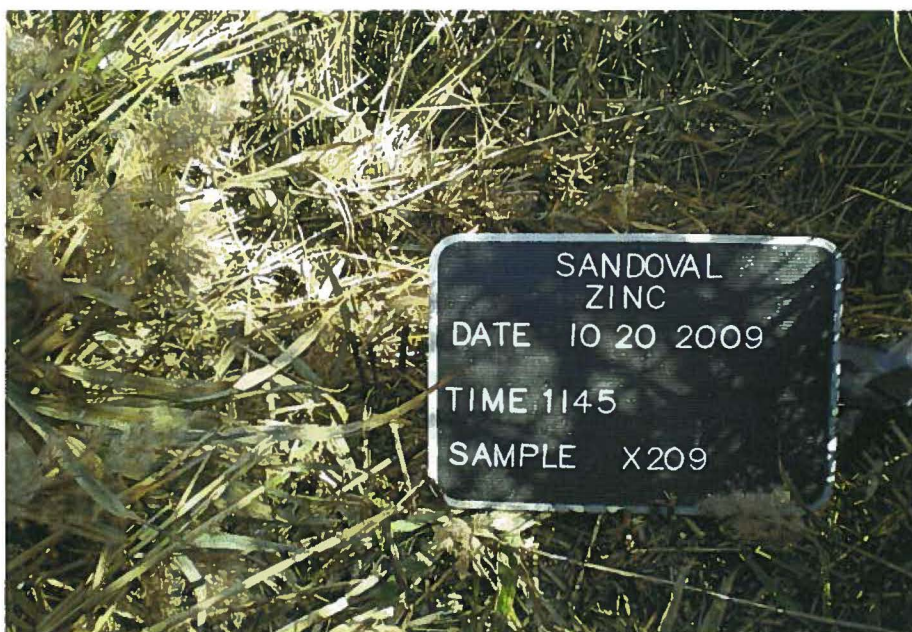
COMMENTS:
 Photo taken of sample location X209. X209 was collected from low lying wetlands. X209 consisted of a brown gritty silt from a depth of 10-12 inches.

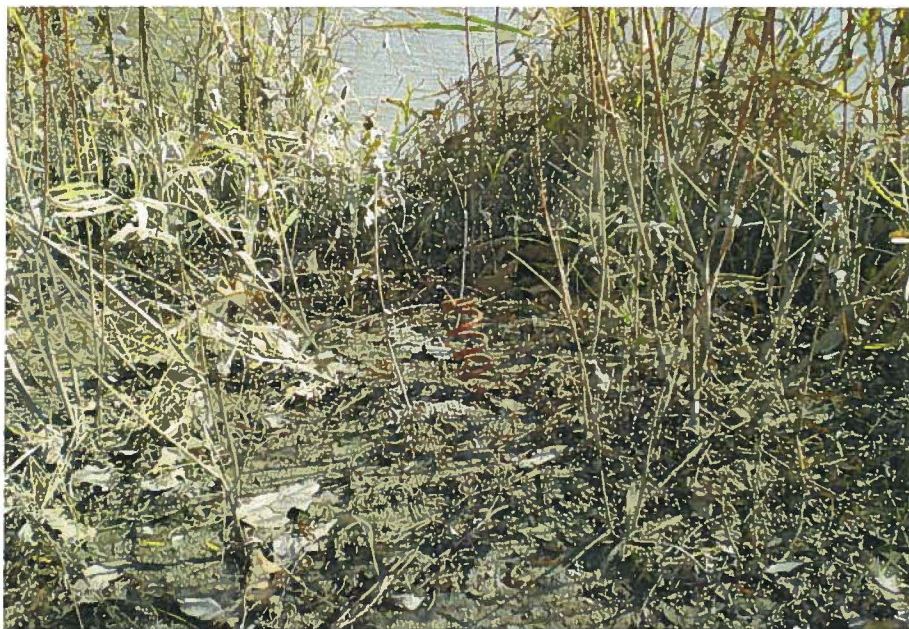
Photo documentation of fishing that has occurred at the pond located east of the site. Notice the pole holder (red in color) which was found along the bank of the pond. This evidence suggests that residents in the area are utilizing the pond for fishing purposes.

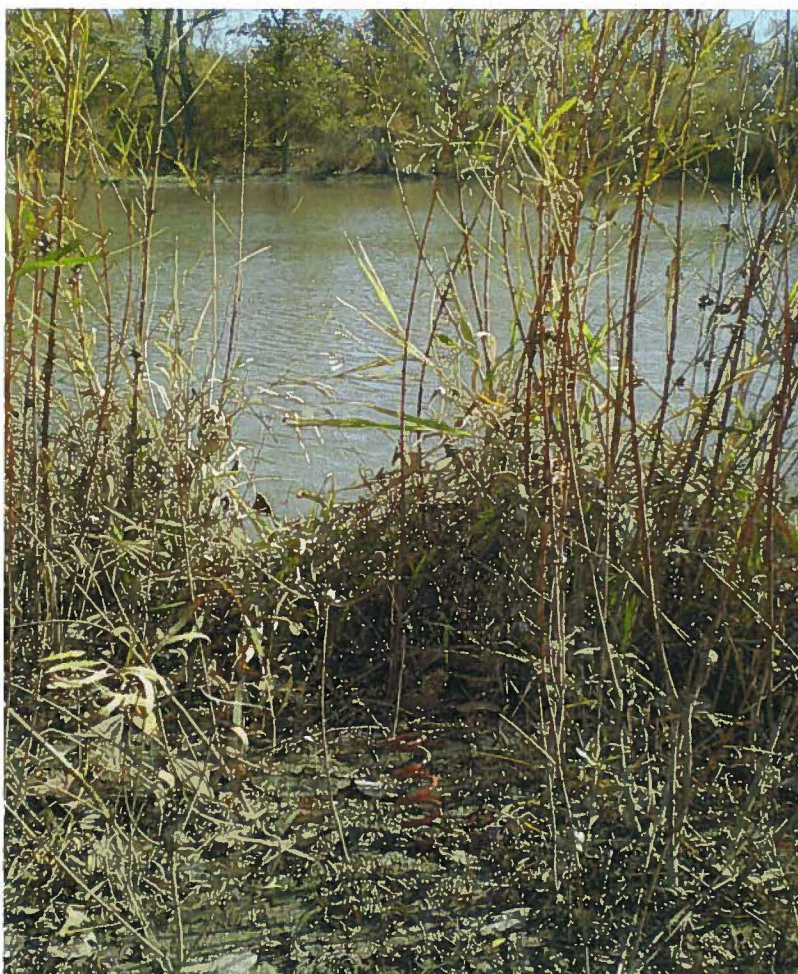
Photo documentation of fishing that has occurred at the pond located east of the site. Notice the pole holder (red in color) which was found along the bank of the pond. This evidence suggests that residents in the area are utilizing the pond for fishing purposes.

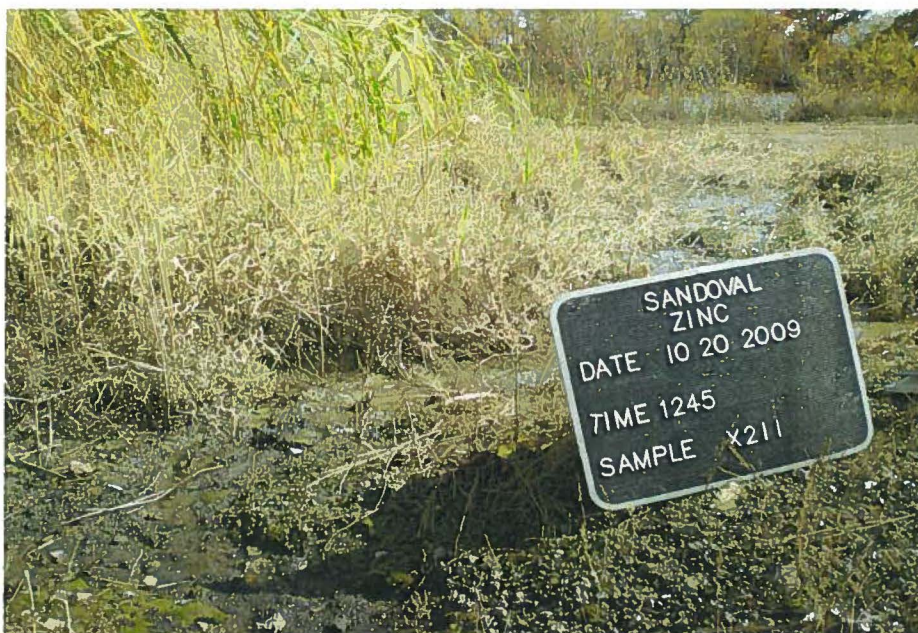
Photo taken of sample location X211. X211 was located at the confluence of drainage from the site to the wetlands located along the eastern edge of the property. X211 consisted of a brown silt with cinders. Collected from a depth of 0-3 inches.

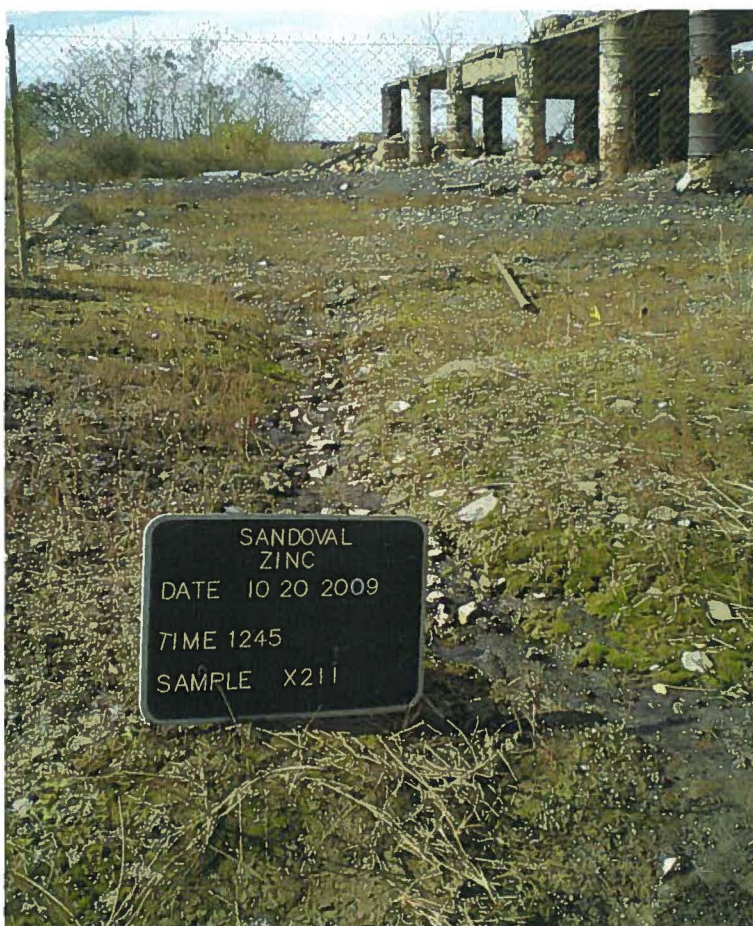
Photo taken of sample location X211. X211 was located at the confluence of drainage from the site to the wetlands located along the eastern edge of the property. X211 consisted of a brown silt with cinders. Collected from a depth of 0-3 inches. Showing drainage from site.

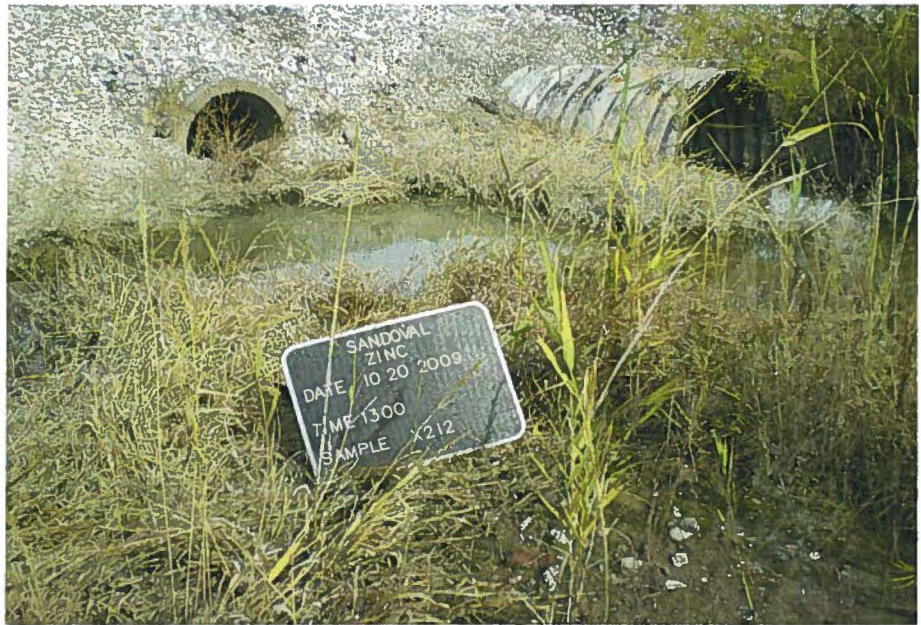
Photo taken of sample location X212. X212 was located in the area of confluence of the drainage from the north side of the property to the wetland area. X212 consisted of a gritty brown silt and was collected from a depth of 0-3 inches.

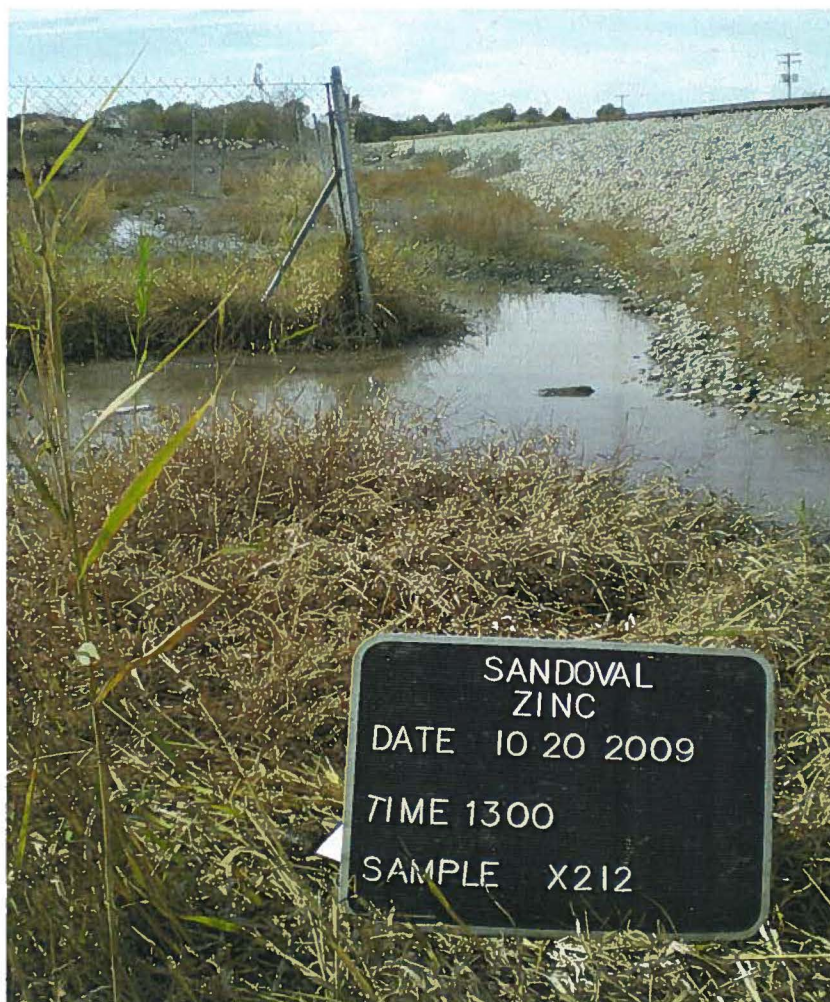
Photo taken of sample location X212. X212 was located in the area of confluence of the drainage from the north side of the property to the wetland area. X212 consisted of a gritty brown silt and was collected from a depth of 0-3 inches.

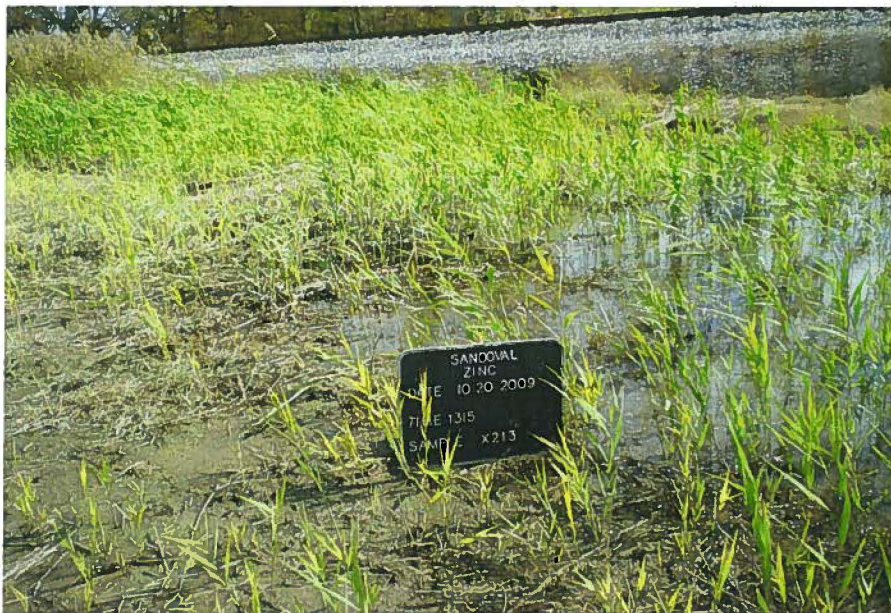
Photo taken of sample location X213. X213 was located on the north side of the tracks from an area which was discharging surface water from the west towards the drainage pipes which pass under the RR tracks. X213 consisted of a light brown silt collected from 0-3 inches.

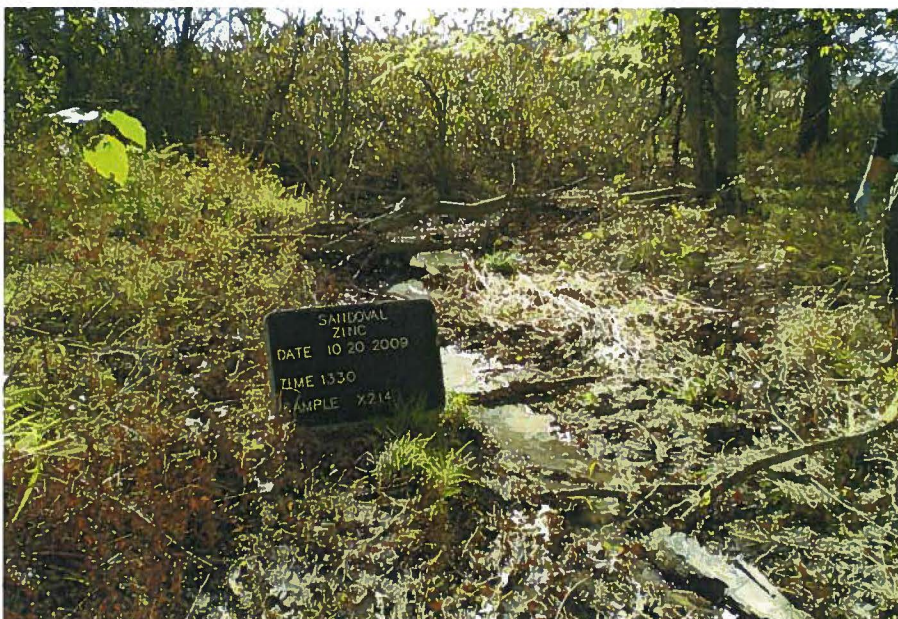
Photo taken of sample location X214. X214 was located from a wooded area located upstream from the site. Sample consisted of a brown silt. Sample was collected from a depth of 0-2 inches.

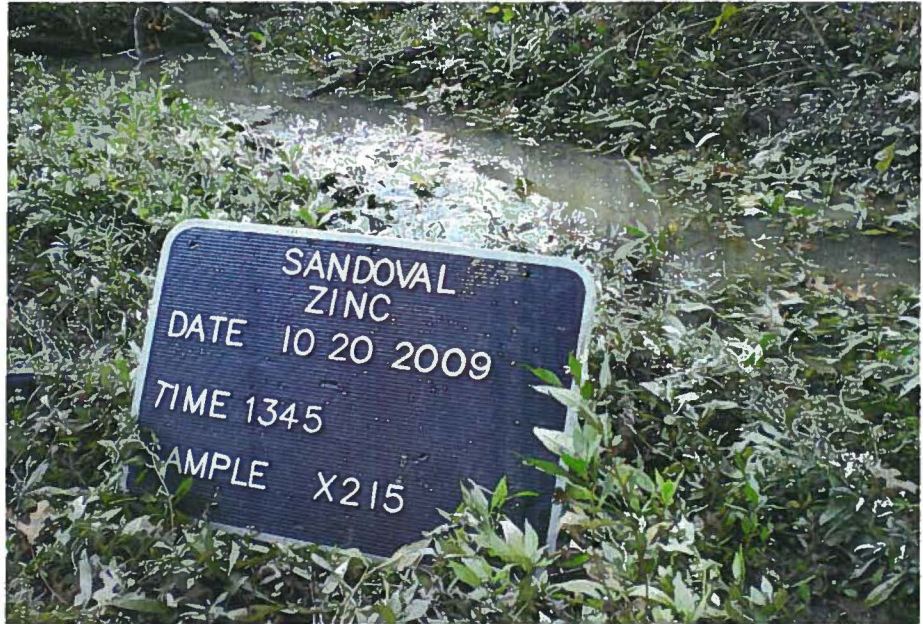
Photo taken of sample location X215. X215 was located upstream of the site in a wooded area. X215 consisted of a brown silt collected from a depth of 0-3 inches.

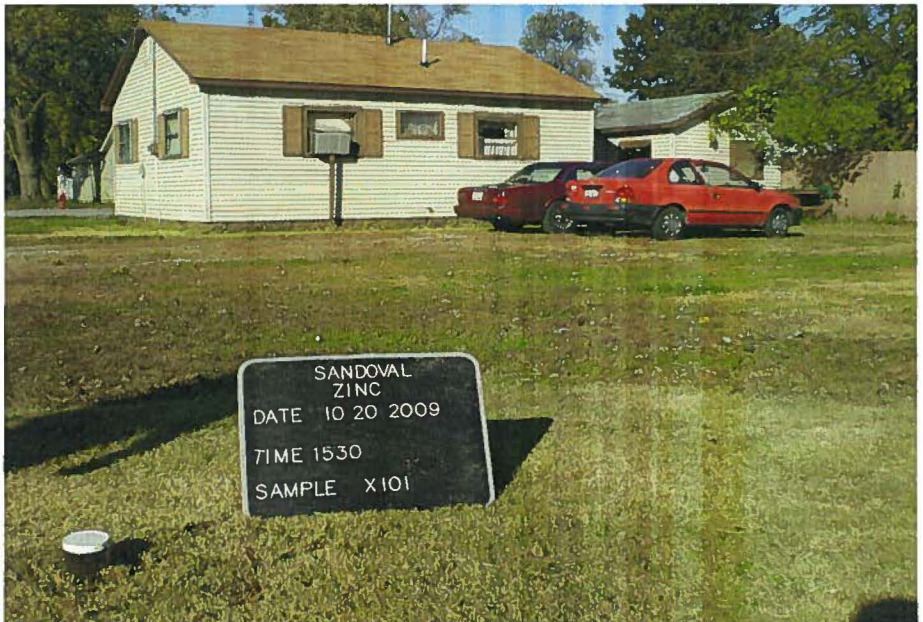
This photo was taken of sample location X101. This sample was collected from a residential yard. X101 was located at the southwest corner of the property from a black cindery material from a depth of 4 inches.

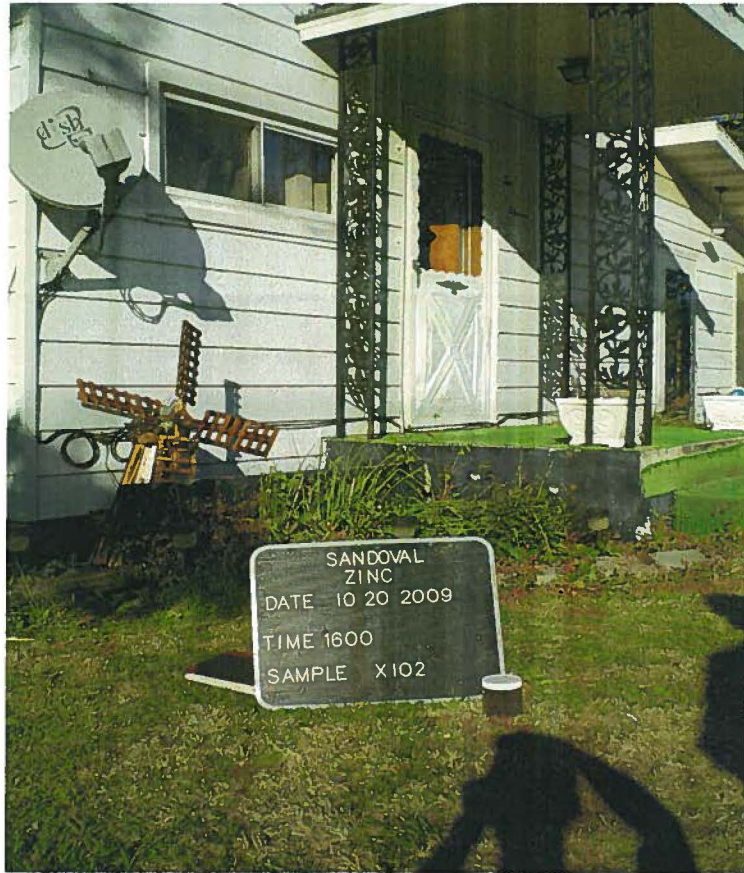
COMMENTS:
 Photo was taken of sample location X102. X102 was located at the southwest corner of the home. Sample consisted of a sandy brown loam and was collected from a depth of 4 inches.

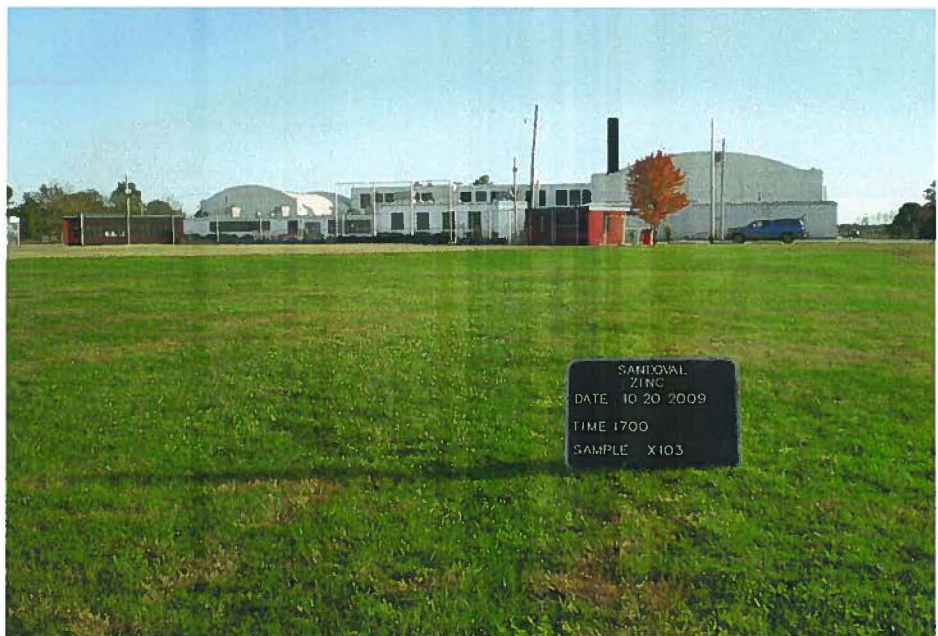
COMMENTS:
 Photo taken of sample X103. This sample was located in the former football field located to the north of the Jr/Sr High School. X103 was collected from a depth of 4 inches from a brown loam, which was just under a peat type layer.

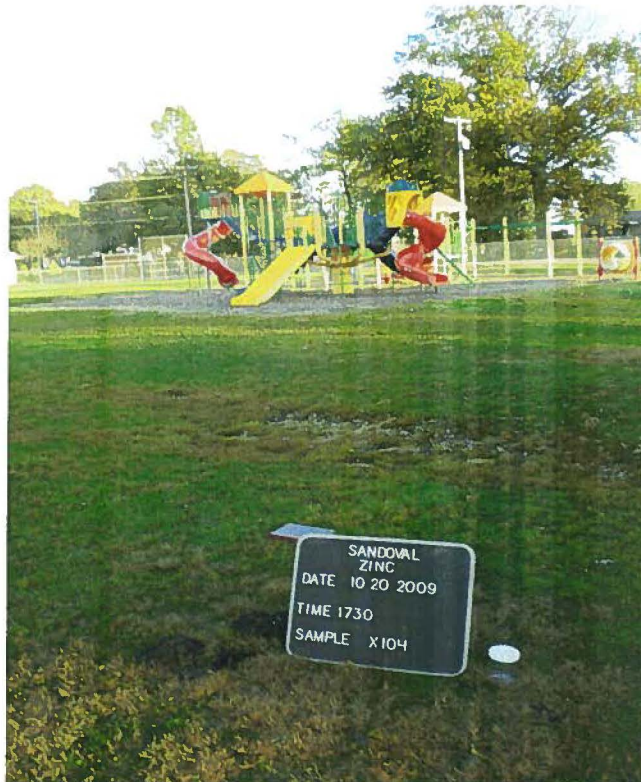
Sample X104 was collected in the play area of the Sandoval elementary school. This play area is located to the south of the school. X104 was collected from a depth of 6 inches from a brown loam with fill material and debris.

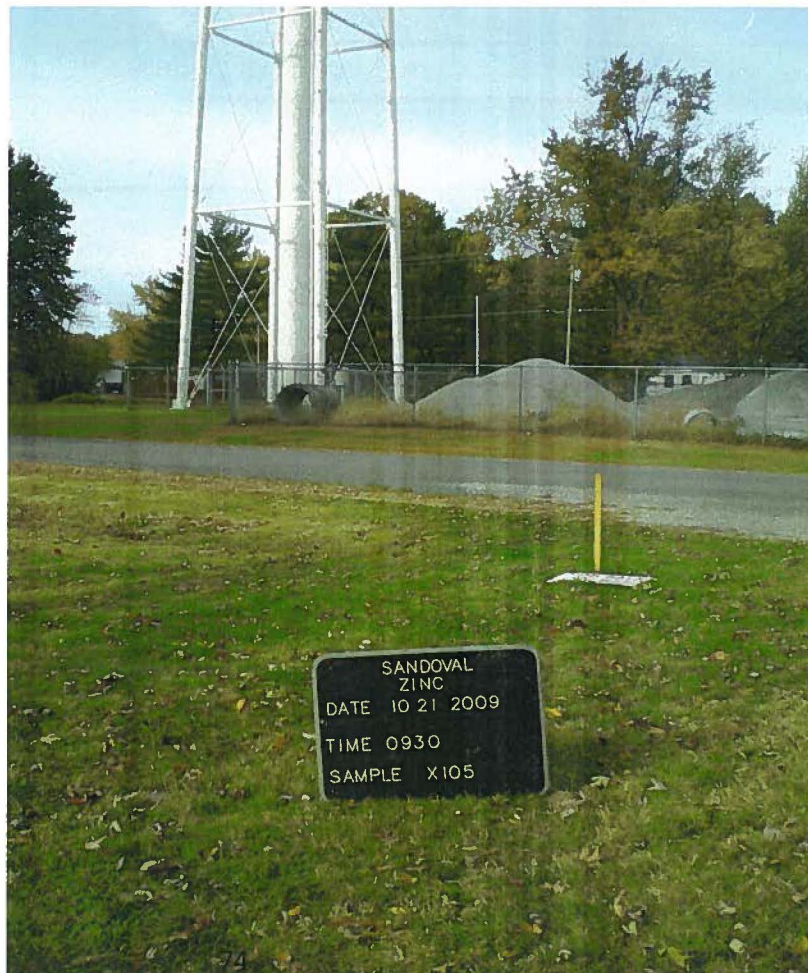
Photo taken of sample location X105. X105 was located at the corner of a residential area just northeast of the watertower. X105 was collected from a brown silty loam interspersed with gravelly fill material from a depth of 6 inches.
